tib 0906-004

Technical Bulletin

RJ-900 and ValueJet CR/Y Overcurrent Errors

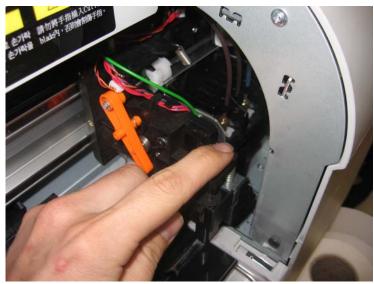
The RJ-900 and ValueJet models up to the VJ1614 all use the original cutter solenoid to release the head lock, as shown below. The machine pictured is an RJ-900; the parts are the same on the VJ-1204 and VJ-1304. The ValueJet 1604 and 1614 require you to reach inside a cutout in the head carriage cover with your finger before you can unlock the head.

Over time, ink can build up on the release mechanism until it begins to stick. When this happens, you will start seeing frequent CR Overcurrent or Y Overcurrent errors as the machine attempts to move the head off the capping station. This can happen either when you first start the machine, or in between print jobs.

The second common cause of these errors is a bent or damaged unlock mechanism. Early model ValueJet 1604s and 1614s had the unlock lever mounted on a bracket that could be easily bent if struck by the head carriage. On the RJ-900, ValueJet 1204 and ValueJet 1304, the lock is much harder to move but occasionally we have seen them drift out of position. In either case, it is possible to either unscrew and realign the head unlock (RJ-900, VJ12 and VJ13), or to bend the bracket back into shape (VJ16). We have not seen any cases where the unlock mechanism could not be cleaned or realigned.

As seen in the image above, it is typically possible to unlock the head carriage by using your finger to click down on the cutter solenoid. About halfway down, you should hear a click and the carriage will move slightly. If you hear the click but the carriage does not move, try to look under the solenoid and see if the release is moving at all.

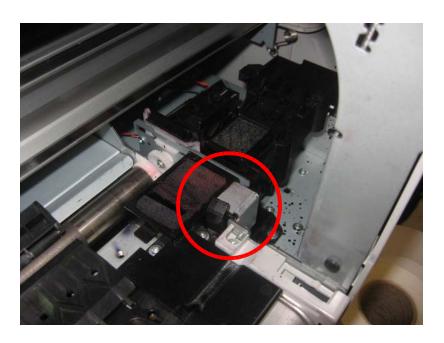
Above is an illustration showing that part of the machine with the head carriage moved out of the way. The release mechanism is circled in red.

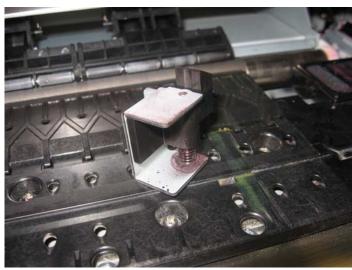
Figure 4. The unlock mechanism after removal. Note the ink buildup on the shaft and at the bottom.

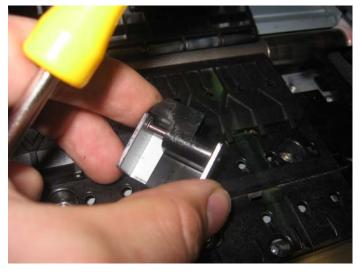
Figure 5. Pushing the unlock mechanism down. It should slide very freely; if it hesitates or binds at all, it will need to be cleaned.
